MURTOA WATER TOWER

FORMER RAILWAY WATER TOWER SOHE 2008

DIAGRAM 1193

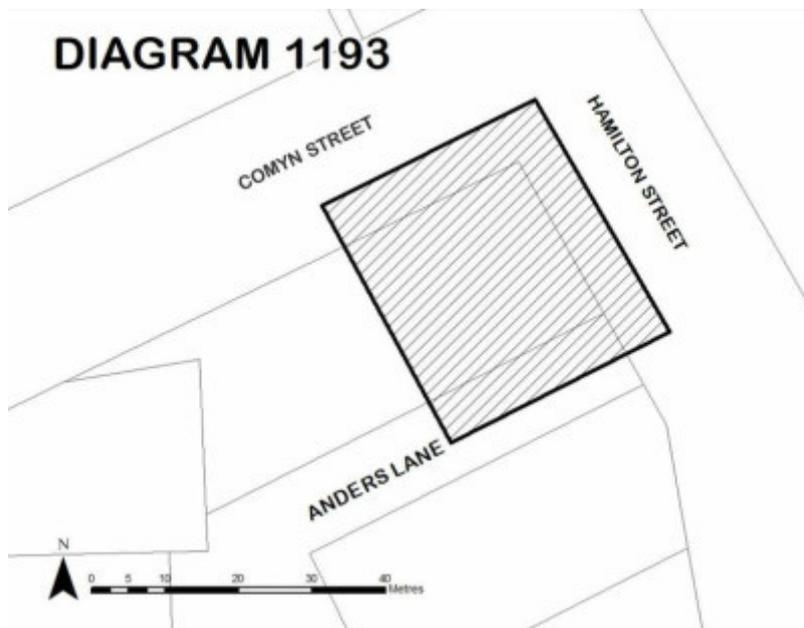
1 former railway water tower
comyn avenue murtoa front view

The Murtoa Water Tower, constructed and opened in 1886, a twelve-metre high, four-storey cylindrical brick tower with a riveted wrought-iron water tank at the top and lifting gear with inbuilt pulley system on the fourth floor.

The Murtoa Water Tower is significant as a notable nineteenth-century water tower demonstrating fine engineering and construction skills to provide a gravity-fed reticulated water supply across a flat landscape. The 182 kilolitre (40,000 gallon) wrought-iron tank is supported by a four-storey brick cylindrical building which ensured sufficient water pressure for the distribution of water pumped from Lake Marma to the nearby Murtoa Railway Station and throughout the town
