Residence

195 Roslyn Road, BELMONT Vic 3216 - Property No 237413

HO1881

Statement of Significance

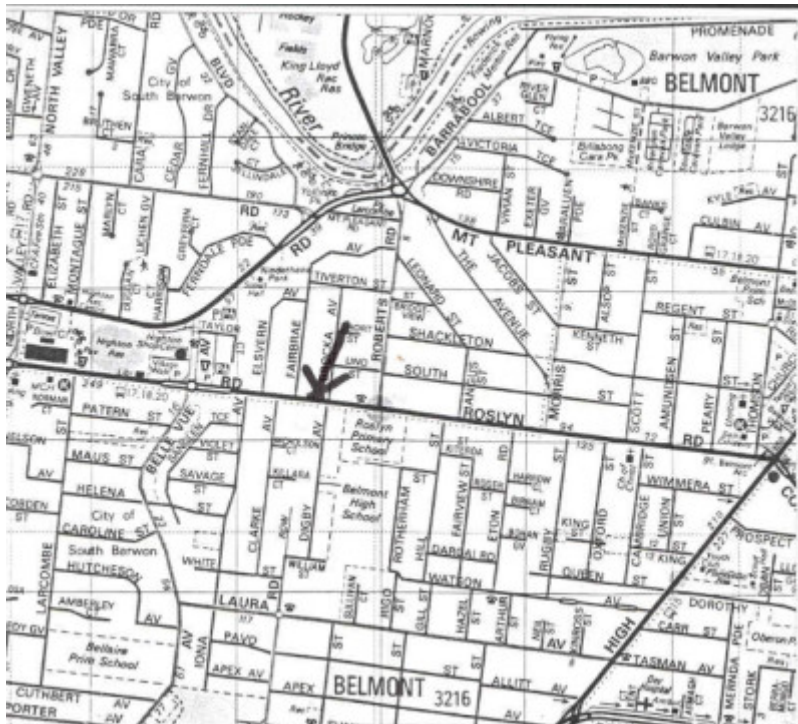
27145 Roslyn Road No 195
Photo

The single storey, asymmetrical, horizontal weatherboard, Federation styled house is characterised by a picturesque arrangement of roof forms, including a central recessed hipped roof, together with projecting minor gables, skillion verandah and window bay. These roof forms are clad in early, painted and lapped galvanised corrugated iron. Three early, unpainted brick chimneys with rendered cappings adorn the roofline. Wide overhangs are a feature of the eaves. The early timber framed windows are fixed and double hung, and the front timber door appears to be early.

A feature of the design is the front verandah that spans across the whole of the street facade, under the projecting gable and skillion. It is supported by early square timber columns, worked timber brackets and distinctive timber fretwork valances. These features are continued at the side to the east, where other porches and verandahs are located. Another feature of the design is the bay window that projects towards the east.

Apart from the verandah elements, early decorative features of the design include the worked timber gable brackets and the gable infill (roughcast panelling, timber battening and small timber brackets).
